Hitachi GST Deskstar HDS721010CLA332 Hard Drive Controller Replacement

Written By: oldturkey03

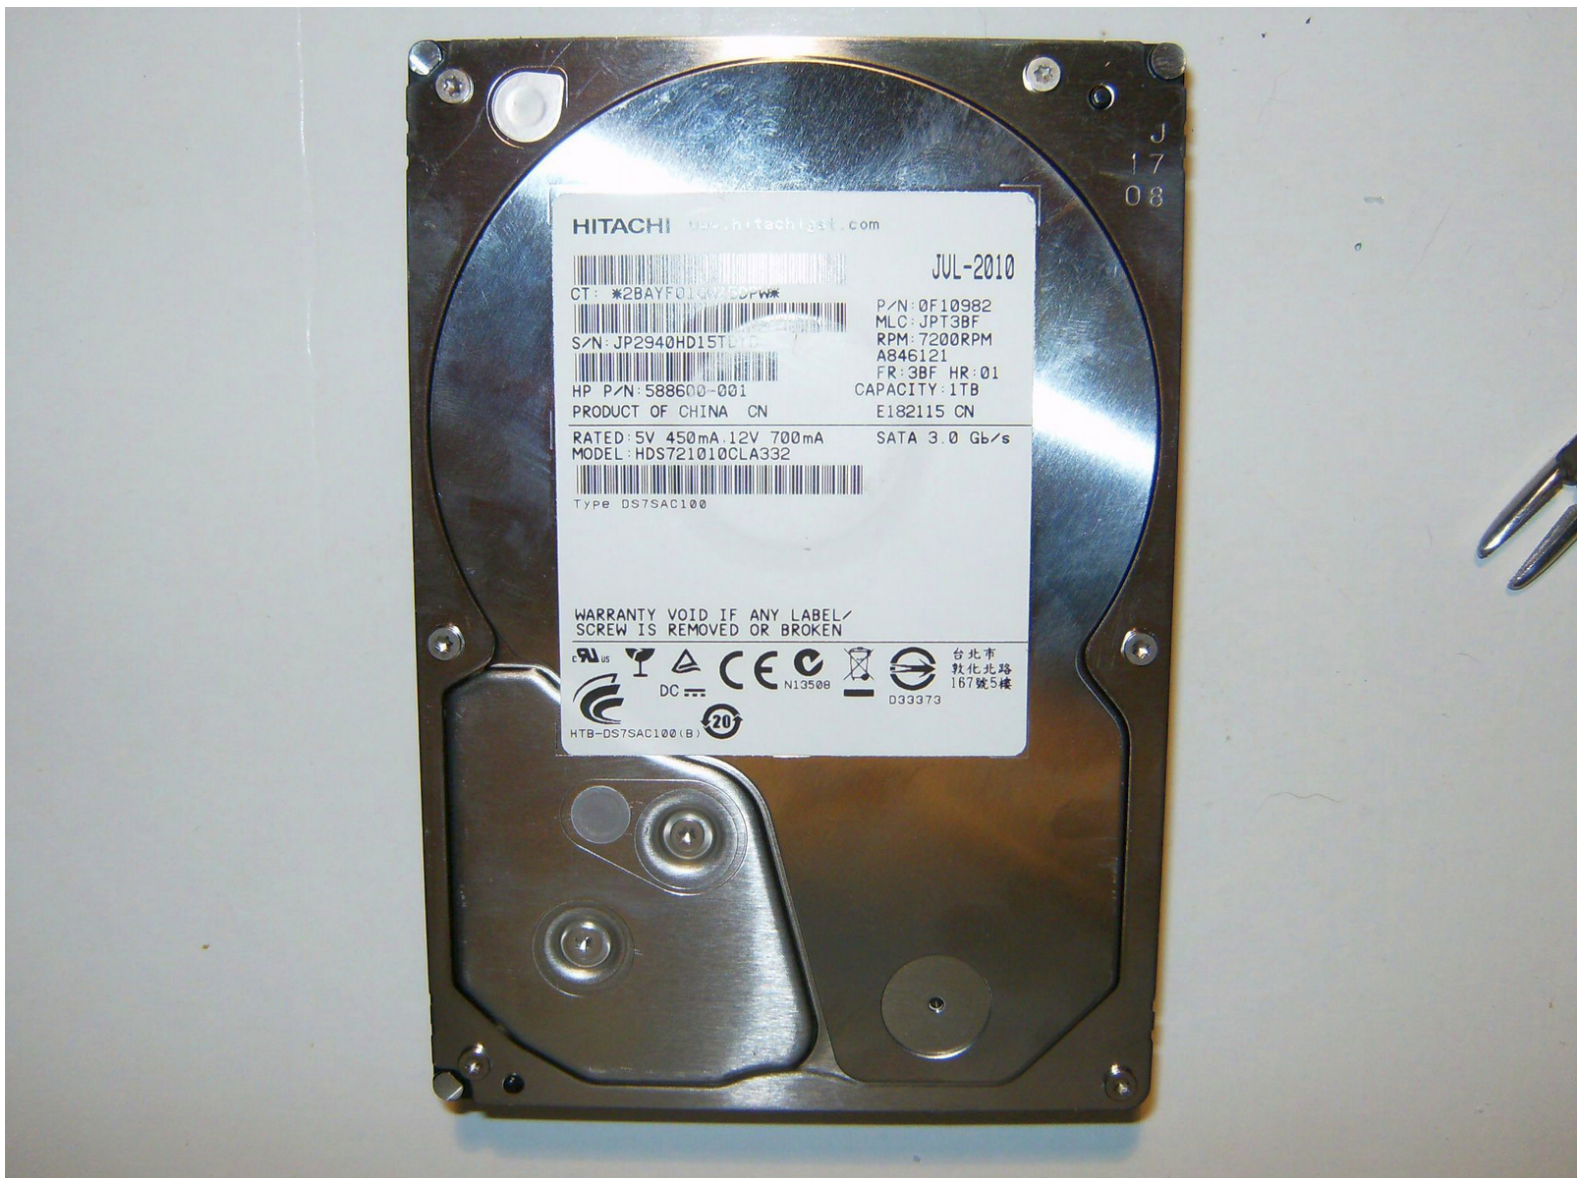
Here is the failed hard drive from the HP 310-1037. When powered on, the computer did not recognize the drive in the BIOS and did not load the OS. The drive was never backed up and the owner really wanted her pictures of the drive. Since the drive did not experience any mechanical damage and, based on the history of these drives with their frequent PCB failure, decision was made to replace the PCB. Hopefully this would revive the drive long enough to remove the needed data.

After replacing the board and replacing the BIOS IC from the original board, the drive was once more recognized. This allowed for the data recovery of some 1000 pictures as well as other documents.

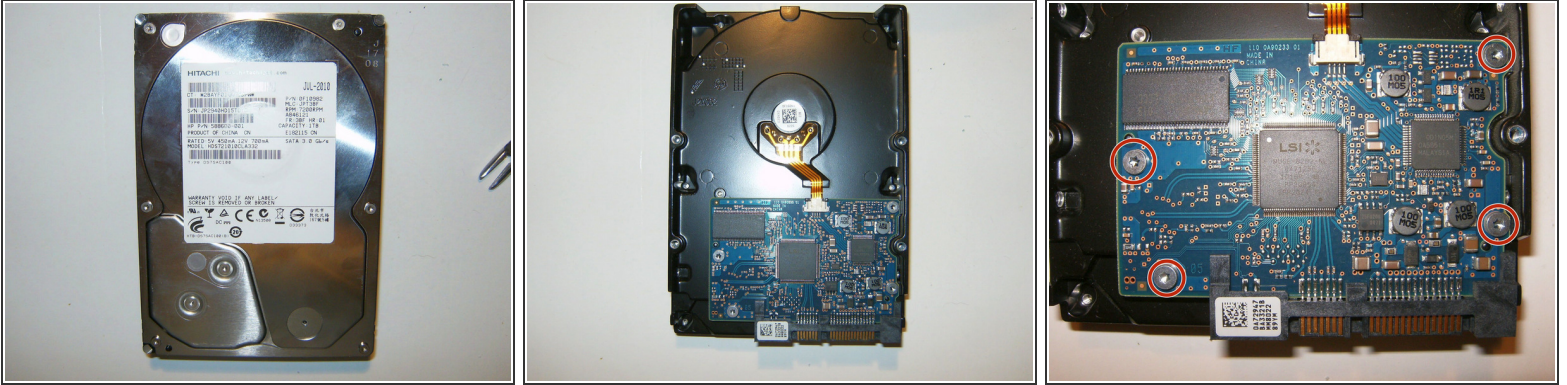
Step 1 — Controller

- Here is the failed Hitachi HDS721010CLA332. It does not get recognized by the computers BIOS and cannot get accessed by any other means. No clicking or other mechanical noises present
- Turn the drive over to get to the controller PCB
- Remove the four T8 screws from the PCB
